Compatibility tests on laminated glass panes with other materials

Ennio Mognato, Alessandra Barbieri, Piero Quaia, Robert Miklus, Danijel Hatezic

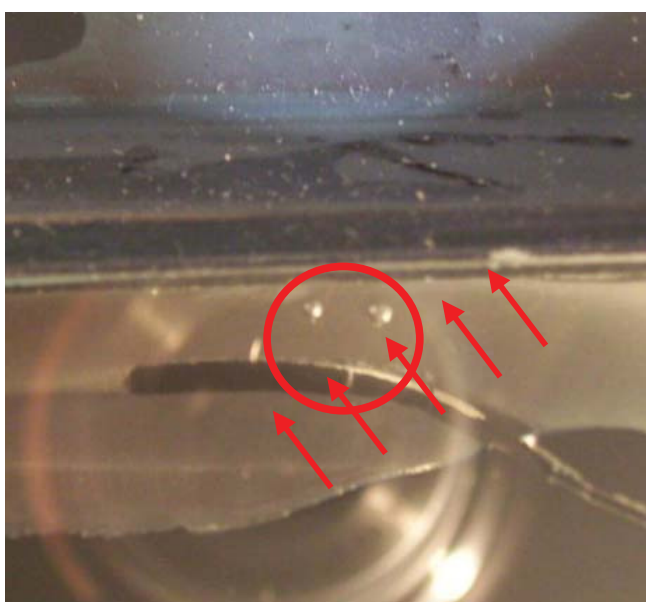
In sample 44.2-HA-E/01, no. 7 bubbles were recorded with penetration depth of $0,5 \div 1,17$ mm and diameter of about $0,6 \div 2,70$ mm (Figure 5a); whereas in samples 44.2-HA-E/02 and 44.2-HA-E/03 some very small bubbles were recorded along the edge (Figure 5b). The defects were evinced after 21 weeks of aging and they were on the pre-lamination finishing, along the adhesion side of bonded gasket.

Figure 5: Defects recorded after 21 weeks at 60°C:
 a) bubbles in sample 44.2-HA-E/01; b) bubbles in sample 44.2-HA-E/03

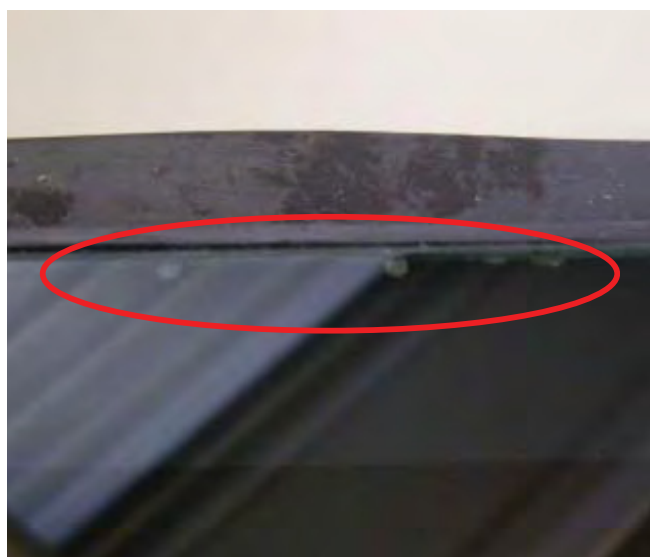
In sample 44.2-LA-E/03, no. 1 bubble was recorded with a diameter of 0,5 mm together with a limited delamination phenomenon which depth was 0,5÷0,75 mm and extension of 1,5÷7,00 mm (Figure 6). The defects were evinced after 21 weeks and only on the post-lamination finishing.

Figure 6 - Defects recorded after 21 weeks at 60°C: bubbles in sample 44.2-LA-E/03

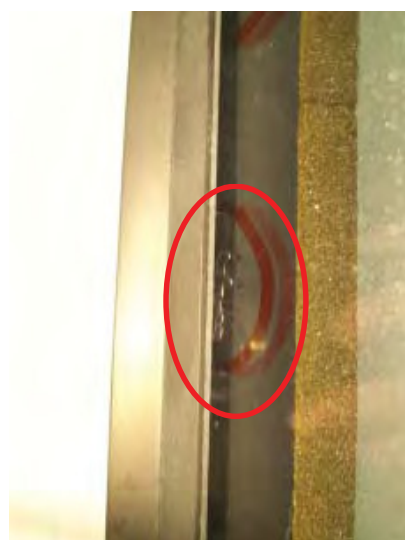
- sample 44.2-HA-B/06: during the first cycle (7 weeks) some small bubble along the pre-lamination finishing for an extension of 27,11 mm with diameter about 0,1÷1,35 mm; no more defect were evinced during the further 7 weeks of irradiation.
- sample 44.2-HA-B/07: delamination phenomenon along the post-lamination finishing with a depth of 2,36 mm and an extension of 68,36 mm (figure 9); after further 7 weeks of UV a small defect increasing was observed (depth up to 3,31 mm and extension up to 69,28 mm);
- sample 44.2-LA-B/06: a single bubble along the pre-lamination finishing with diameter of 1,39 mm.

Figure 9: "Delamination" in sample 44.2-HA-B/07, after 7 weeks UV irradiation test

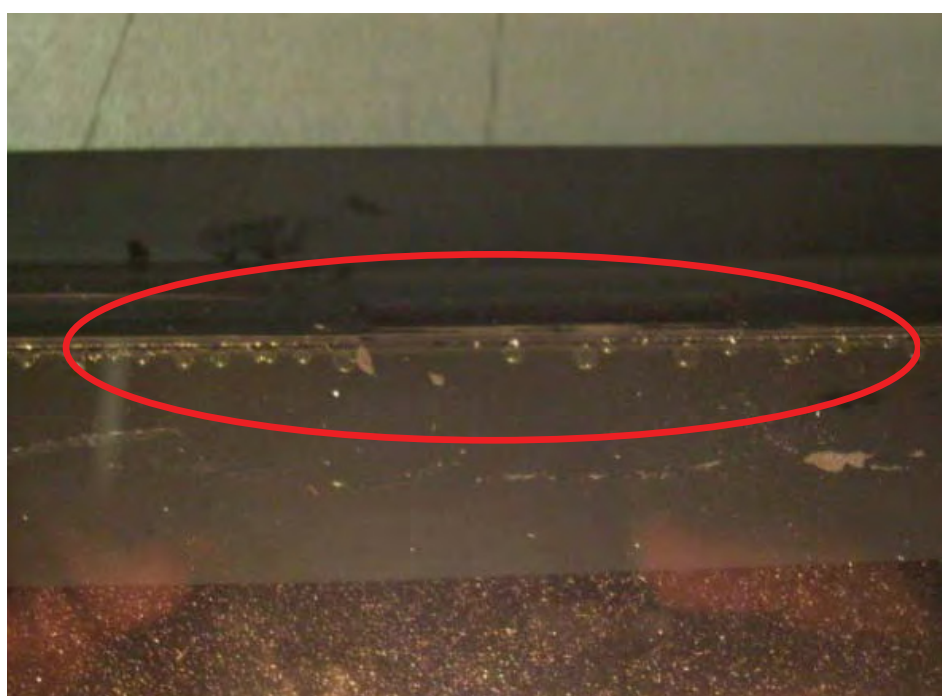
- sample 44.2-HA-C/06: some small bubbles along pre-lamination finishing with a depth of 0,05 mm and an extension of 28,32÷68,20 mm; the mean value of diameter was 0,1 mm; after further 7 weeks the extension the defect increased up to 84,46 mm;
- sample 44.2-HA-C/07: a delamination phenomenon along the pre-lamination finishing with a depth of 1,57÷3,09 mm, for an extension of 12,51÷14,71 mm (Figure 10); after further 7 weeks the extension increased up to 13,07 mm, with an increment of depth 1,73÷3,20 mm.

Figure 10 - Bubbles in sample 44.2-HA-C/07, after 7 weeks UV irradiation test

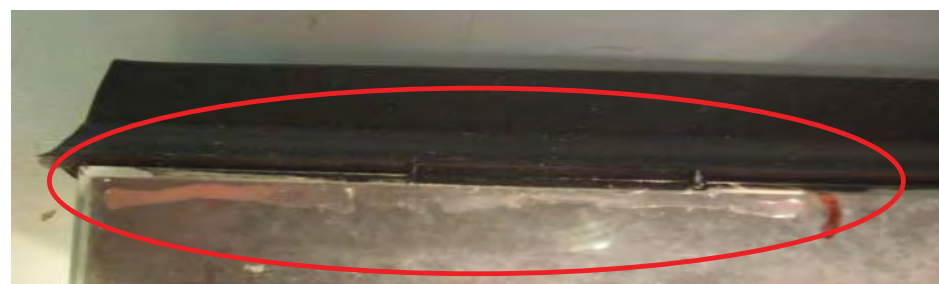
- sample 44.2-LA-E/05: small bubbles along the pre- and post-lamination finishing with a mean diameter of 0,1 mm (Figure 11) and a delamination defect near the corner of post-lamination finishing with a depth of 1,50 ÷ 3,61 mm and extension of 62,5 mm (Figure 12); these defects increased lightly after further 7 weeks of UV aging;

Figure 11 - Delamination on sample 44.2-LA-E/05, after 7 weeks UV irradiation test

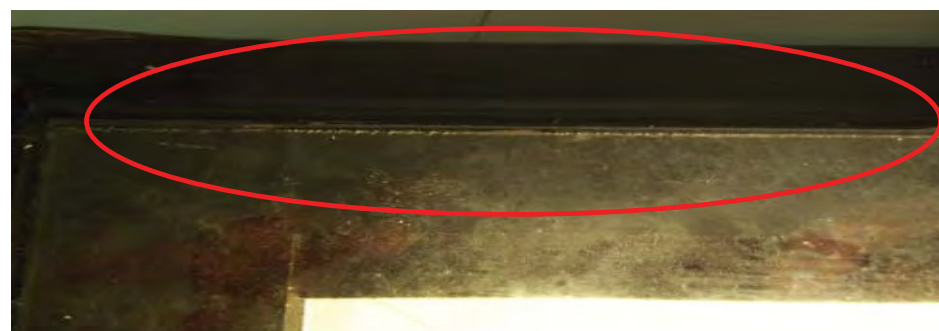
Figure 12 - Bubbles on sample 44.2-LA-E/05, after 7 weeks UV irradiation test

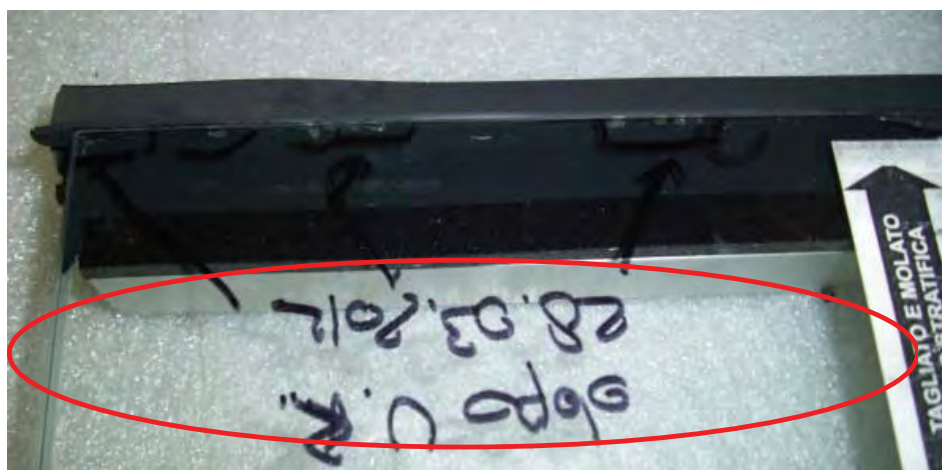
The tests referred to points 1), 2) e 3) did not evinced the presence of new defect and that recorded in the previous test were stable. There was only one case in which further defects arose: sample 44.2-LA-E/03 in which, at the end of the high humidity test at point 3), a delamination phenomenon appeared along post-lamination finishing, where acetic silicone had not been applied (Figure 13).

Figure 13 - Bubbles in sample 44.2-LA-E/03, after 2 weeks of high humidity test preceded by 2 weeks of high temperature test at 60°C

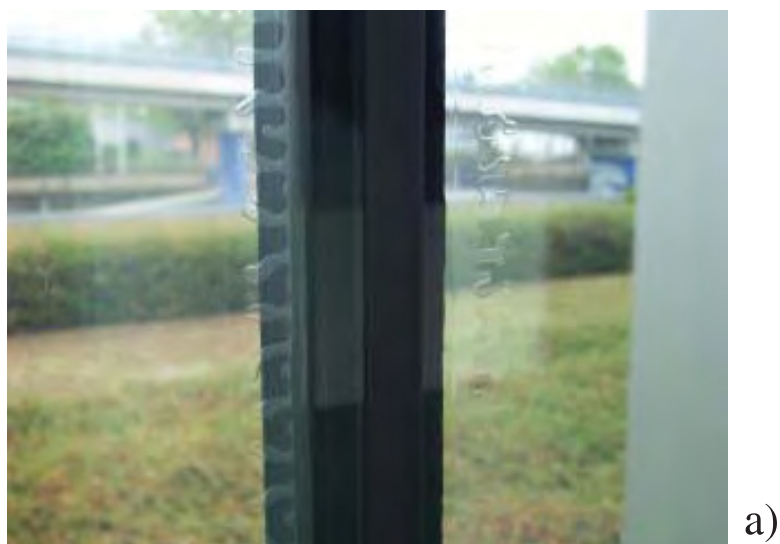
It was never detected in the tested glass following the exposed procedures an evident and clear phenomenon of interlayer contamination, similar to what is sometimes found in some applications on glazing facades (Figure 14), or other types of application.

Figure 14 - Defect in IGU with laminated glass pane:
a) defect starting from the glass pane edge; b) defect starting from a bubble
