Compatibility tests on laminated glass panes with other materials

Ennio Mognato, Alessandra Barbieri, Piero Quaia, Robert Miklus, Danijel Hatezic

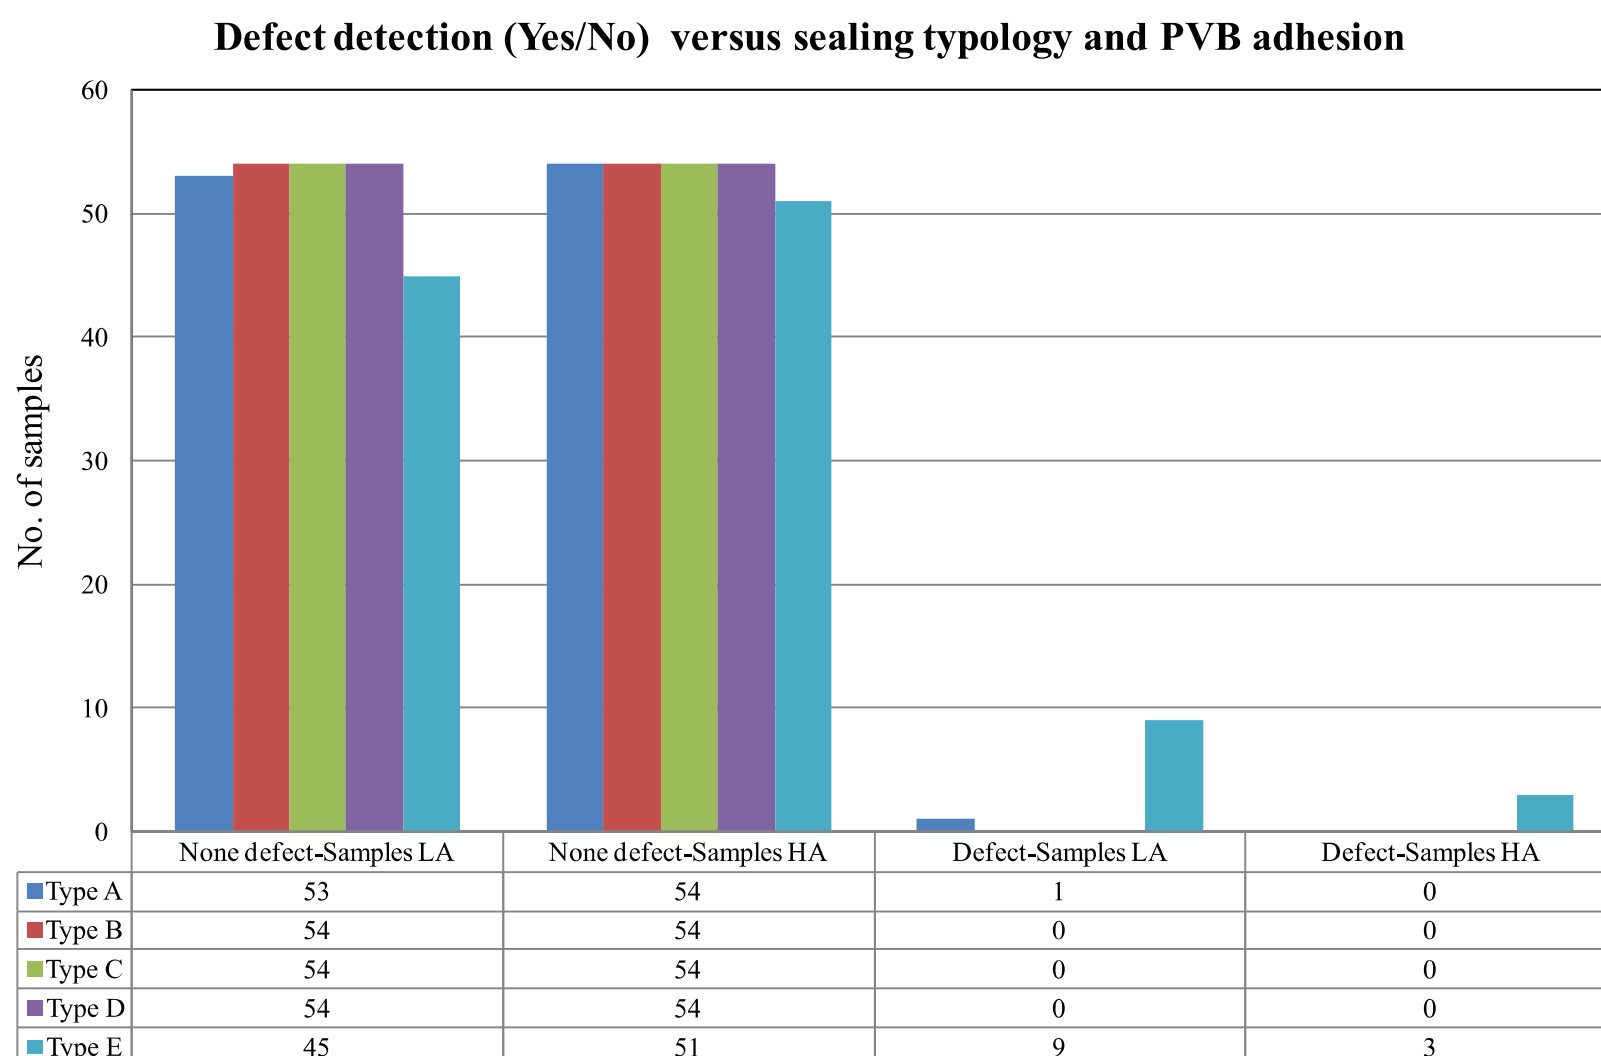
The sampling type E - both with high adhesion PVB both low adhesion one - was come out that it was more vulnerable than the others to high temperature test. It has been observed the occurrence of bubbles of small size near the edges of the panes, without distinction on the type of interlayer adhesion. In figures 3 and 4 the results of high temperature test are plotted versus sealant typology and testing time.

Figure 3: Defect detection versus sealing typology and PVB adhesion: HT test

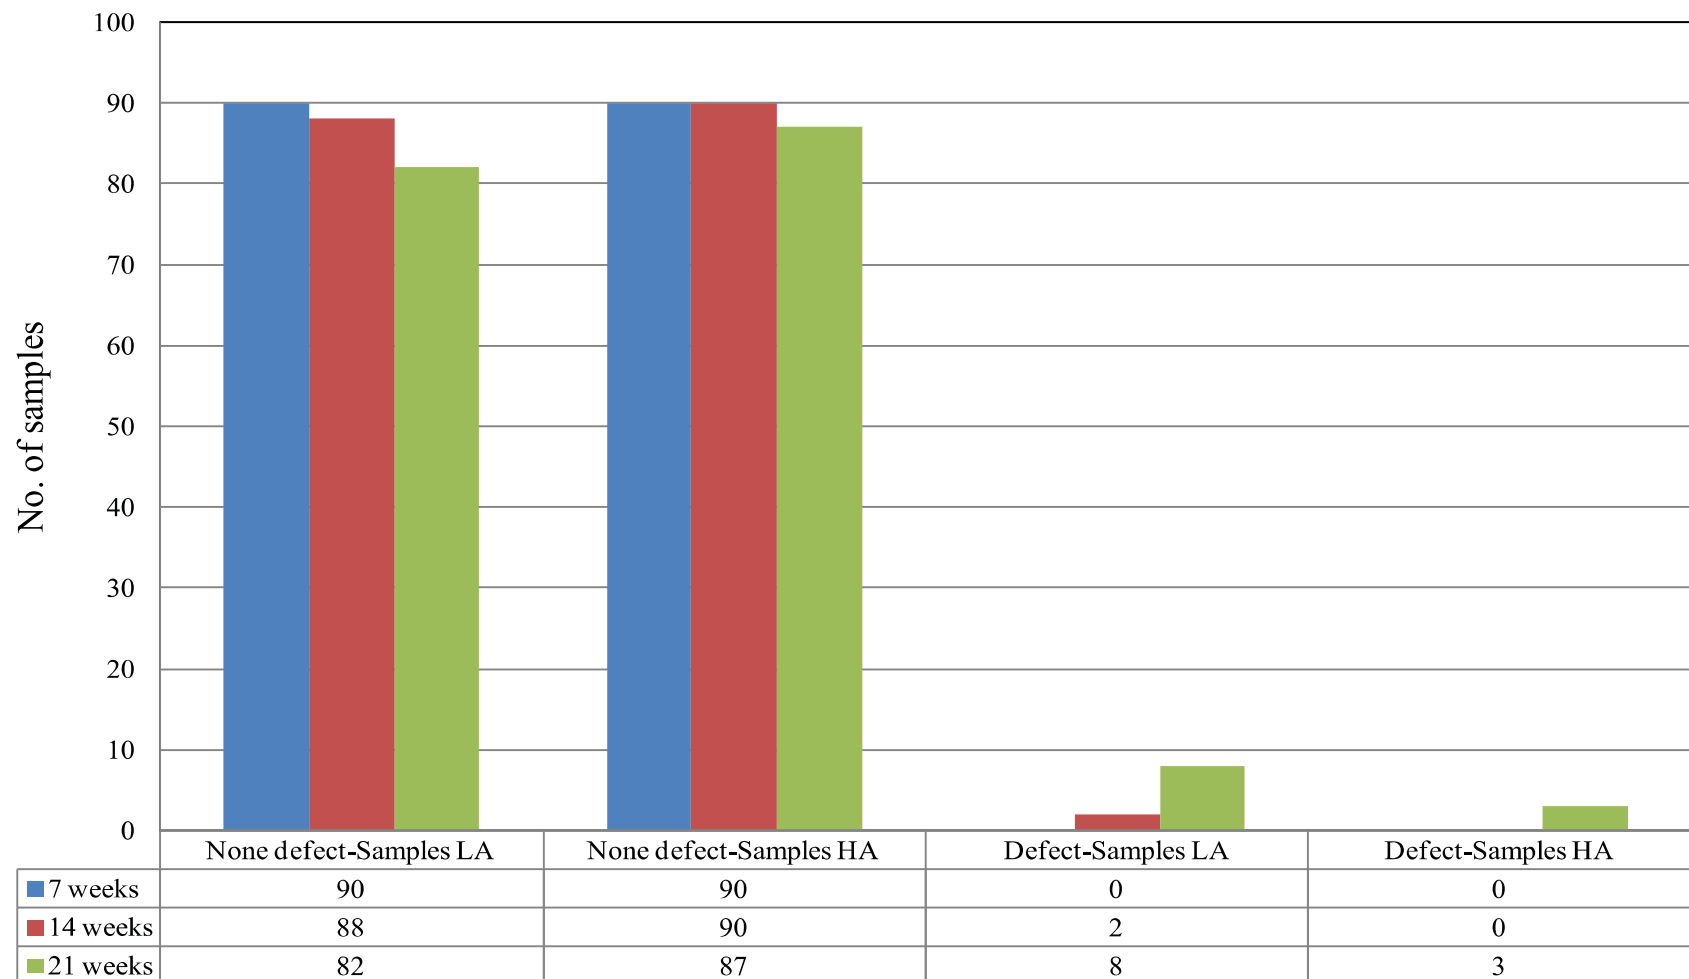
Figure 4: Defect detection versus testing time and PVB adhesion: HT test

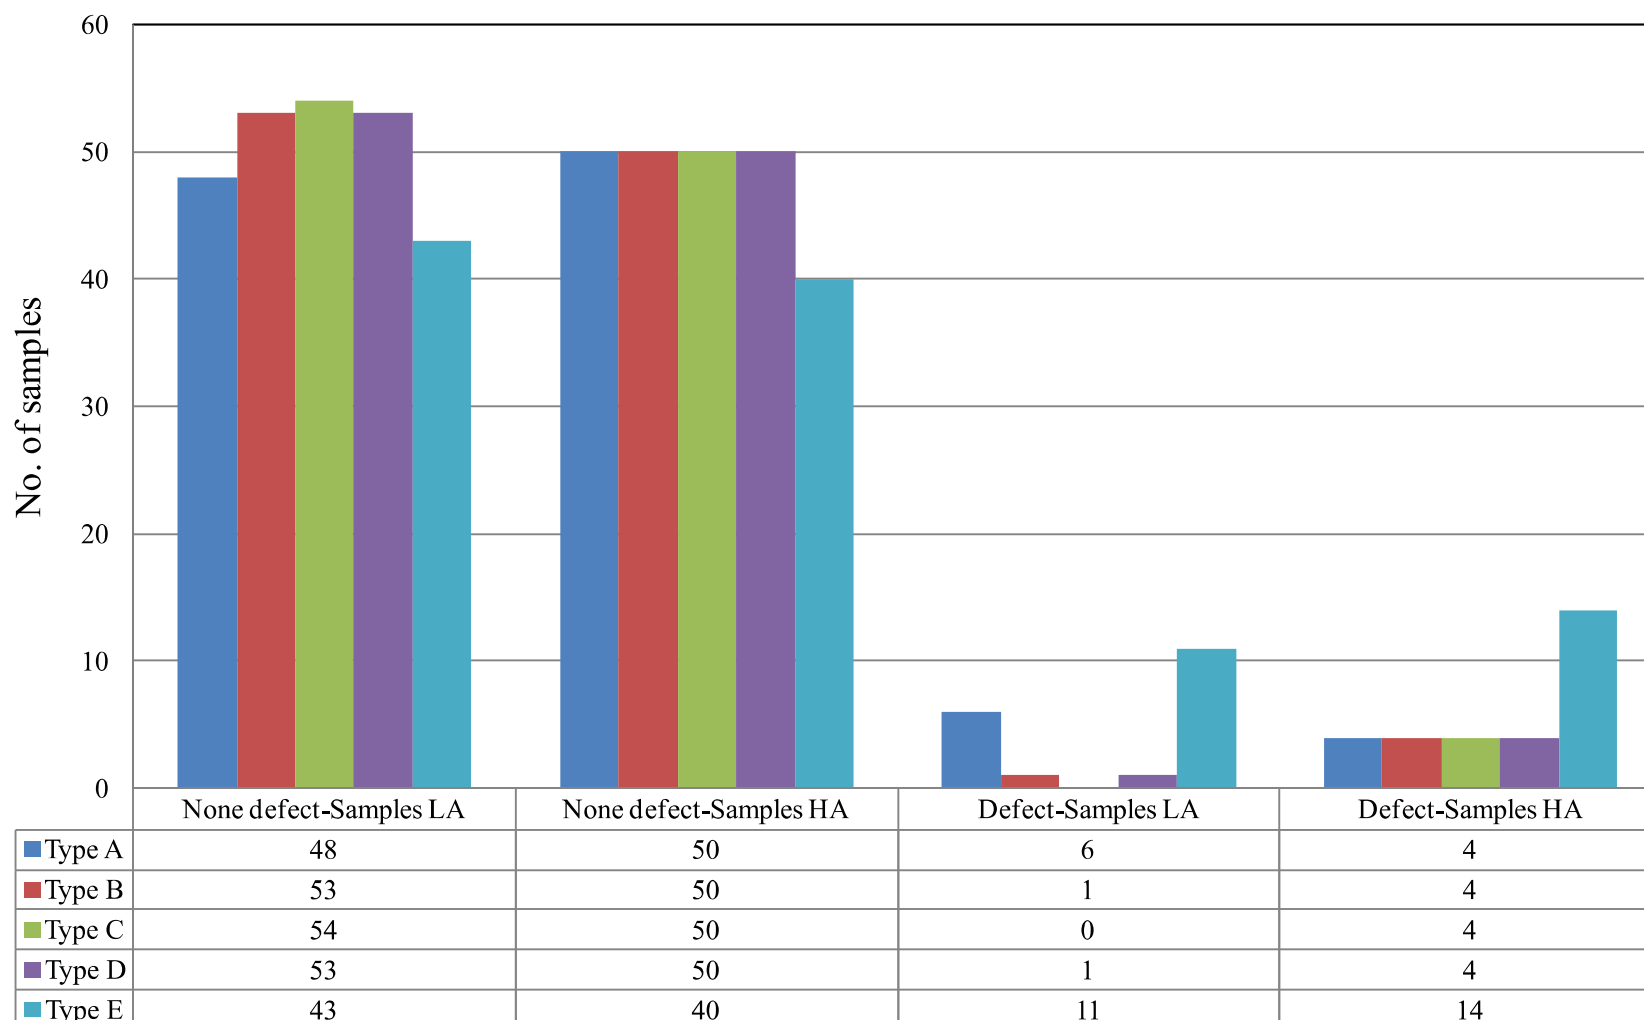
In figures 7 and 8 the results of high temperature test are plotted versus sealant typology and testing time.

Figure 7 - Defect detection versus sealing typology and PVB adhesion: R.U. + UV test

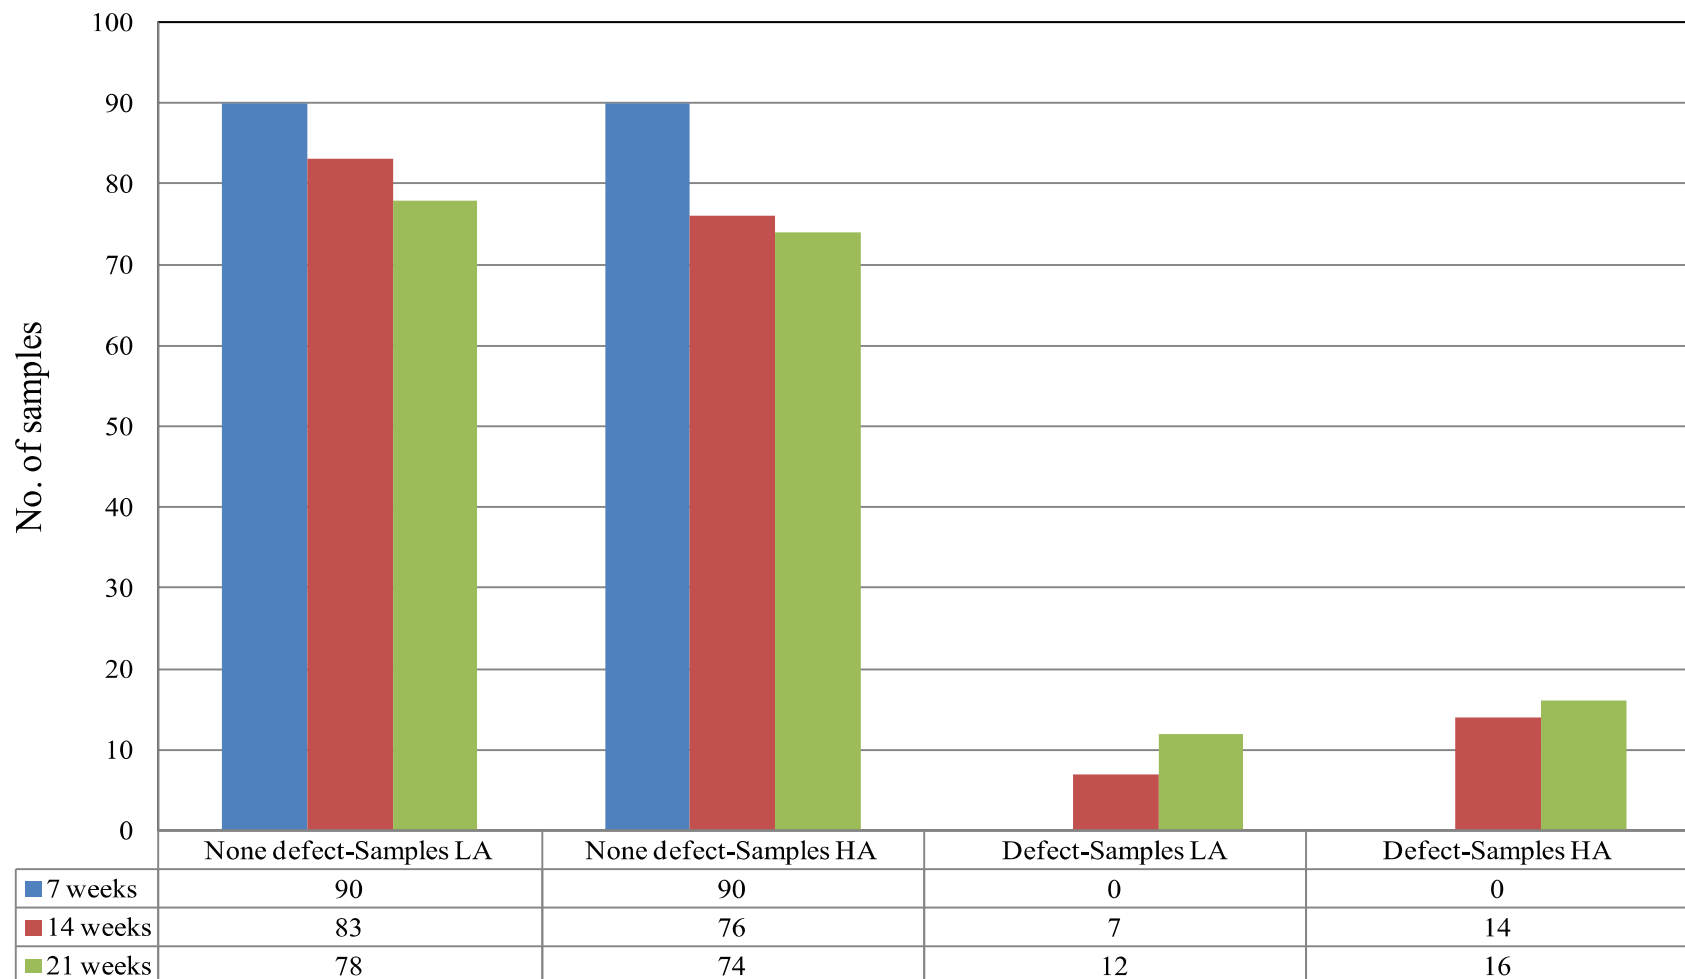
Figure 8 - Defect detection versus testing time and PVB adhesion: R.U. + UV test

The samples did not evinced defects after 7 weeks in climate chamber.
